Manhole Inspection Summary

Manhole # S21EE_030MH

Insp Date: **6/28/07 8:01 AM**

Location Address: **1706 LAURENS ST**

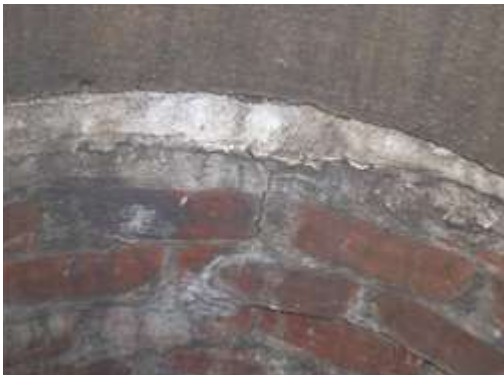
Defect 2

Condition: ☐ Sound ☒ **Cracked** ☐ Root Intrusion ☐ Loose Brick ☐ Deteriorated

CRACKED CORBEL

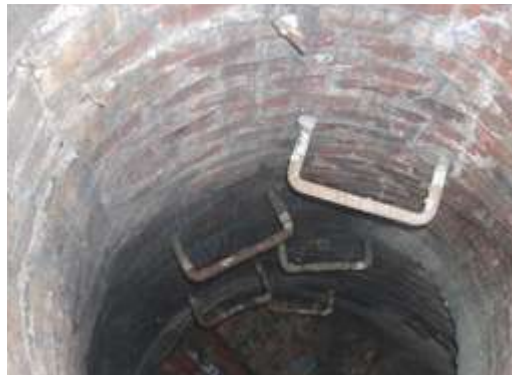
Defect 1

Count: **5** Missing: **1** ☒ **Corroded**

MISSING AND CORRODED STEPS

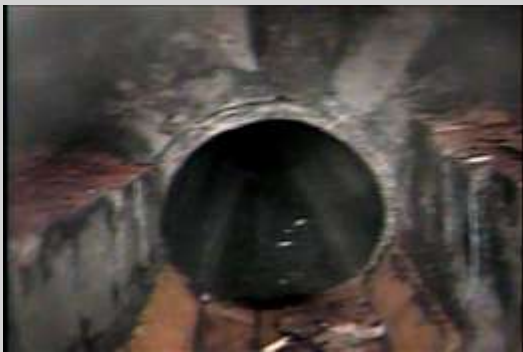
12 O'Clock Outflow

8 in. Circular Gravity Sewer
Pipe Out @ 12 O'Clock

Pipe Height: **8.4** (in.) Rod and Bar (Angled)
Pipe Material: **Clay** ☐ Pipe Lined
Invert Depth: **10.31** (ft.) Flow Characteristics: **Slow**
Deposits: ☒ None ☐ Mud ☐ Sludge ☐ Debris ☐ Grease
Silt Depth: (in.) Deposits Extent:
Infiltration: **None** Pipe Seal Cond: **Sound**

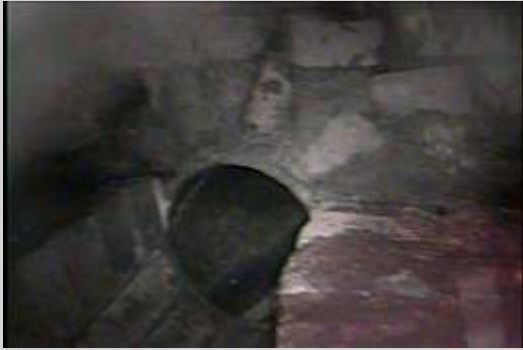
7 O'Clock Inflow

8 in. Circular Gravity Sewer

Pipe In @ 9 O'Clock

Pipe Height: **8.4** (in.) Rod and Bar (Angled)

Pipe Material: **Clay** ☐ Pipe Lined

Invert Depth: **9.88** (ft.) Flow Characteristics: **Slow**

Infiltration: **None** Pipe Seal Cond: **Sound**
